Technical Report ARMET-TR-10001

## **CRITICAL FLAW ESTIMATE AND FLAW ANALYSIS OF 81-mm M821A1 MORTAR PROJECTILE**

June 2010

**U.S. ARMY ARMAMENT RESEARCH, DEVELOPMENT AND  
ENGINEERING CENTER**

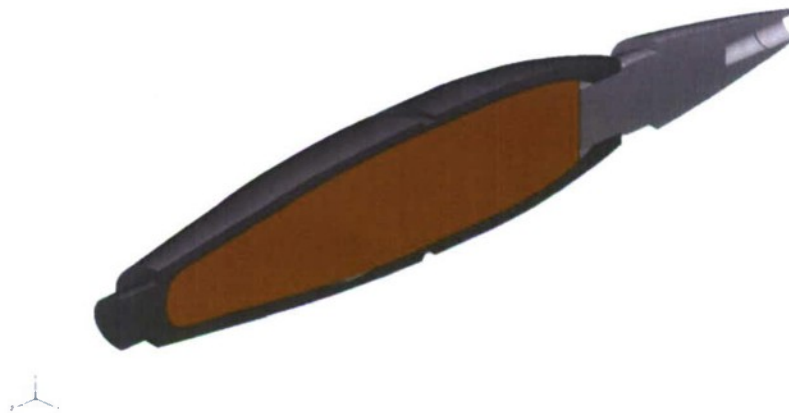
Figure 3  
Geometry of M821A1 projectile with flaws

The M821A1 assembly consists of three components with the part of interest being the M821A1 shell. The fuze and round composition were also incorporated into the assembly. Figure 3 shows the geometry. It was assumed that the shell was completely filled with composition B and additional components, such as the explosive train, were ignored. This was done because the purpose of the analysis was to focus on the shell. The explosives housed within it were irrelevant. The composition B was included to ensure that the round would not be simulated as hollow. For the flaw analysis, the shell was modeled with a defect on the interior surface. The flaw was dimensioned with a maximum depth of one third the wall thickness and a length that was twice the width. An internal flaw in the shell was incorporated approximately half-way through the shell with a depth of one fourth the wall thickness. The geometries of these flaws are representative of the observed defects in the M821A1 body, roughly (fig. 1).

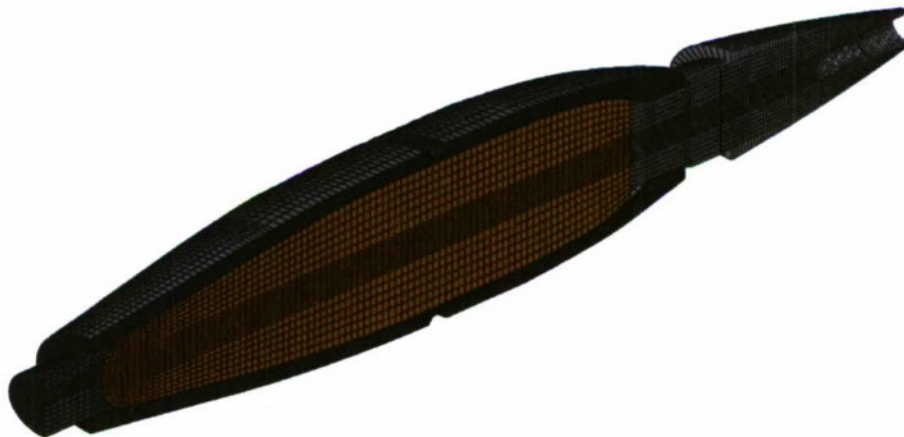
Figure 4  
Finite element mesh of the assembly

A total of 111,201 hexahedral reduced integration mesh elements (C3D8R) with enhanced hour glass controls were used in the analysis. The overall geometry of the applied mesh can be seen in figure 4. Table 2 summarizes the number of elements used for each part. Refined meshes with a total of 17,516 elements were applied around the flaws to further improve the accuracy of the analysis. Approximately 25% of the elements used to model the shell were focused around the flaws. The mesh used for the interior flaw can be seen in figure 5. The mesh used for the internal flaw is shown in figure 6. A similar mesh to figure 4 was also used for the critical flaw size estimates. For critical flaw estimates, eight elements were used through the thickness to sufficiently represent the hoop and axial stress distributions.

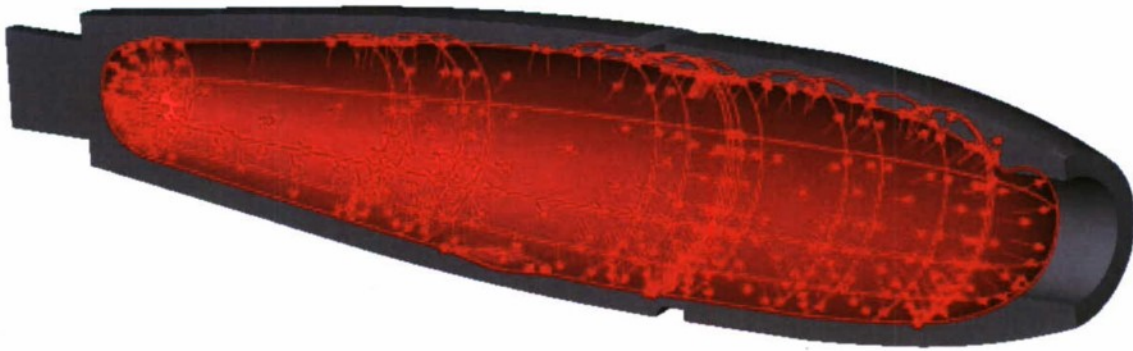
Figure 7  
Hydrostatic test loads on the shell body

To simulate hydrostatic testing, the inner surface of the M821A1 shell was subjected to a maximum loading of 67.2 MPa (fig. 7). The loading was applied using a smooth step curve increasing from zero pressure to maximum loading over 0.003 sec. Upon completion of this time interval, the loading was removed using a smooth step curve decreasing from maximum loading to zero pressure.
